DEER CROSSING SIGNS AND TECHNOLOGIES

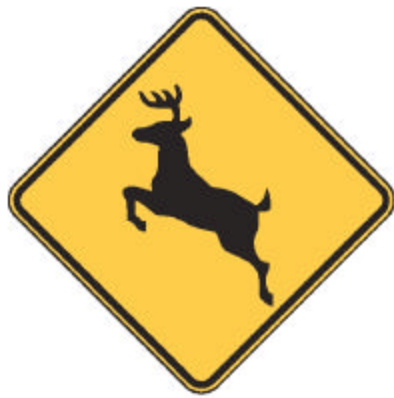
W11-3

One of the most widely used measures to reduce deer-vehicle crashes (DVCs) is the deer crossing warning sign (See Figure 1). The design of this sign is controlled by the *Manual on Uniform Traffic Control Devices* (MUTCD), and consists of a diamond-shaped panel with a black “Deer Crossing” legend or deer symbol and a yellow background (See Figure 1) (1).

FIGURE 1 Typical deer symbol crossing warning sign (1).

No research literature was found that specifically considered or quantified the DVC reduction and/or vehicle speed reduction impacts of typical deer crossing signs (See Figure 1). The deer crossing sign studies that were reviewed appear to be based on the general assumption that a typical deer crossing warning sign does not generally reduce vehicle speeds (one measure of warning sign effectiveness), and that the effectiveness of these signs needs to be improved in some manner.

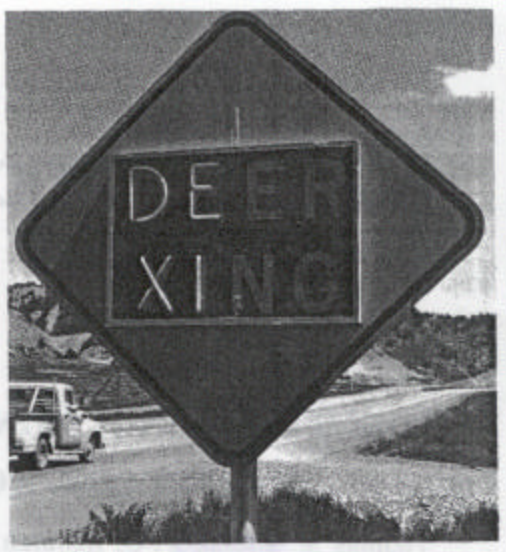
Pojar, et al. have evaluated the impacts of two enhanced deer crossing sign designs (2, 3, 4). These designs are shown in Figures 2 and 3. The first sign evaluated was a typical diamond-shaped yellow and black warning sign with the words “DEER XING” in neon lights (See Figure 2). The other sign was also a diamond-shaped yellow and black warning sign, but included a series of deer shaped lights that activated in sequence and gave the impression of a deer jumping (See Figure 3). A small rectangular supplementary “DEER XING” sign was also added to this installation (See Figure 3). The impact of these signs was measured by comparing average operating vehicle speeds when the signs were turned toward and away from the traffic.

FIGURE 2 Lighted “DEER XING” sign (3).

In 1971 the signs in Figure 2 and 3 were installed along Colorado State Highway 82 (3). First, the “DEER XING” sign in Figure 2 was installed, but turned away from the traffic for 16 days (3). Then, the sign was turned towards traffic and activated for 28 days (3). After the “DEER XING” sign was removed it was replaced with the animated sign in Figure 3 for four days (3).

In the first two studies summarized in this document Pojar, et al. concluded that the lighted sign design improvements they proposed (See Figures 2 and 3) and evaluated did

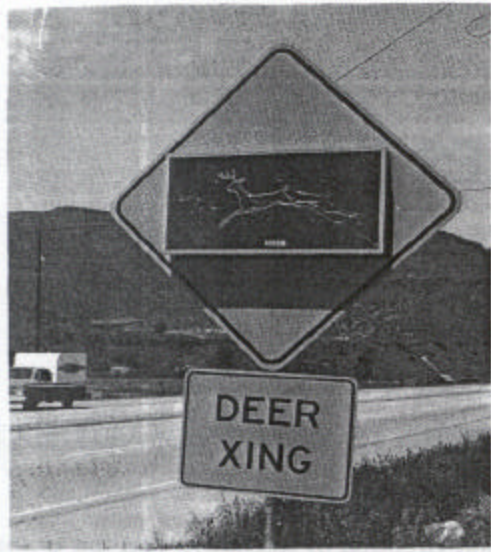
FIGURE 3 Animated deer crossing sign (3).

Pojar, et al. have also documented a more in-depth impact analysis of the animated sign design shown in Figure 3 (4). This study was conducted along the same highway segment as the initial study, but vehicle speed data were recorded 0.15, 0.65, and 1.5 miles downstream of the sign installation (4). This data was again collected with magnetic loops from 6:00 PM to 10:00 PM when the highway surface was dry (4). The researchers also estimated the number of nightly deer crossings in this 1.5-mile segment with spotlight surveys (one hour after sunset) within one area along its length, and recorded the number and location of deer roadkill within the study segment (4). The number of nightly deer crossings was estimated by simply doubling the number of deer counted by the researchers that night (4). In other words, it was assumed that each deer observed would cross the roadway at least twice that night. Finally, a short preliminary analysis of the vehicle speed impact of placing a deer carcass next to the sign treatment was also completed (4).

In 1972 and 1973, Pojar, et al. activated the animated sign in Figure 3 for two and five weeks (4). Those weeks when the sign was turned toward traffic (or activated) were alternated with weeks during which the sign was turned away from traffic (4). The number of weeks that vehicle speeds, deer crossings, and deer roadkill data were collected and/or estimated, along with the ratio of estimated deer crossings and roadkill are shown in Table 2 (4).

significantly reduce average vehicle speeds. However, the outcome of a more in-depth study of the animated design (See Figure 3) did not appear to indicate that its resultant vehicle speed reduction had actually resulted in a reduction of the number of deer roadkill (i.e., DVCs) in the study area (See Table 2). However, the variability in DVCs and the factors that impact their occurrence limits the validity and transferability of the study results presented here because they are based only on 15 weeks of data.

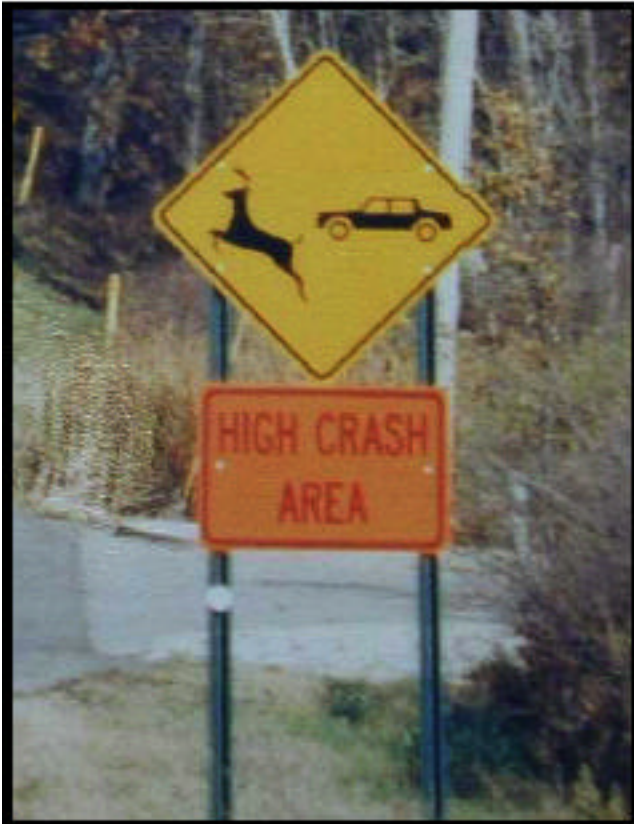
FIGURE 5 Michigan temporary deer crossing sign design (6).

The researchers in Michigan collected and compared DVC and vehicle speed data to evaluate the impact of the seven specially signed roadway segments (6). A comparison of two years of DVC data, however, showed no reduction in this type of crash after the signs were installed within either the entire township or along the roadway segments with

The seasonal use of specially designed deer crossing signs was also considered in two states (See Figures 4 and 5). Researchers in Utah installed signs during the mule deer migratory season, and observed reductions in vehicle speed and DVCs. However, researchers in Michigan investigated the impact of a different deer crossing sign design that was installed during the fall months (a “high” DVC and white-tailed deer movement time period), and generally found no significant reduction in DVCs or vehicle speed. The differences in these two studies include sign design, animal species, and apparently the general ability of drivers to appropriately assess the risk of a collision at a particular time and location. In Utah the familiarity of the drivers with the distinct migratory seasons and locations of the mule deer were believed to have had an impact on the sign effectiveness. It is proposed that more consistent and incremental studies may be needed to support or refute the speed- and DVC-reduction impacts of properly installed (i.e., at “high” DVC locations) deer crossing signs for both the existing and any proposed designs. An incremental approach (e.g., first add an additional text message, then reflectorized flags, and then amber flashing lights) may be necessary to determine what changes to deer crossing signs are the most effective. The appropriate use of temporary signs is clearly less expensive than some of other potential DVC countermeasures discussed in this toolbox.

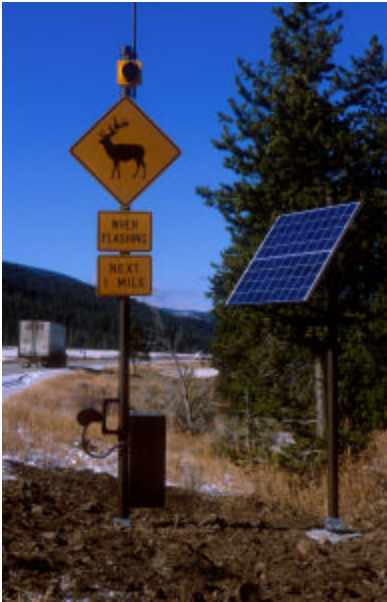
The research described previously investigated the impacts of enhanced deer crossing sign designs. If used, these enhanced signs are either constantly active or must be turned away from traffic. More recently, a number of dynamic sign and sensor systems have been proposed and/or installed. These systems typically alert the driver, through flashing lights for example, when an animal has been detected near the roadway. An example of some of the equipment used by one dynamic sign and sensor system is shown in Figures 6 and 7.

FIGURE 6 Dynamic elk sign and sensor system example (*Photo courtesy of the Western Transportation Institute*).

- In Minnesota, a dynamic sign and system has been installed at one location, and is planned for two other sites (8). The choice of locations was based on deer population and DVC data. The system uses an infrared light beam on both sides of the roadway to detect animal movement, and when these sensors are activated a battery-powered transmitter turns on amber warning lights on top of a series of traditional deer crossing signs (8).
- In Montana, the Western Transportation Institute has also installed and is testing a dynamic sign and sensor system that operates with radar beam sensor equipment connected to amber lights on traditional elk crossing and “When Flashing” sign installations (9). This is the system shown in Figures 6 and 7.

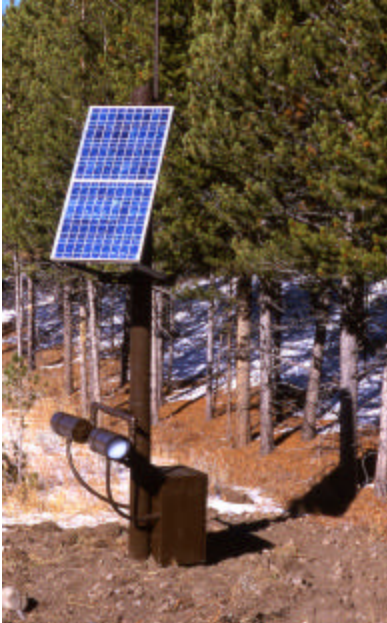
FIGURE 7 Solar powered animal sensors (*Photo courtesy of the Western Transportation Institute*).
